Manhole Inspection Summary

Manhole # S57K__010MH

Insp Date: **5/14/08 1:38 PM**

Location Address: **631 S GRUNDY AVE**

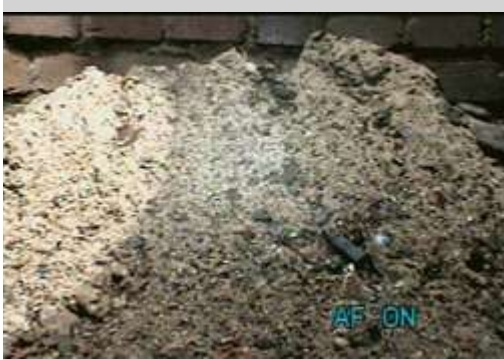
Defect 1

Condition: ☐ Sound ☐ Cracked ☐ Root Intrusion ☐ Deteriorated ☐ Leaks ☒ Debris

debris

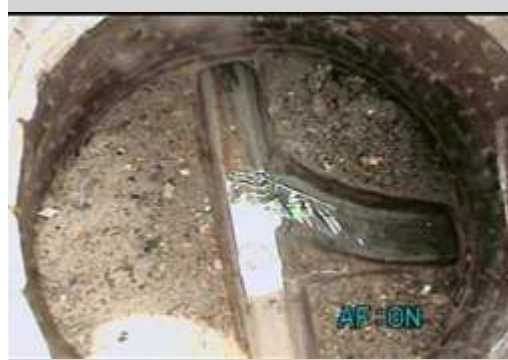
Defect 2

Corroded step

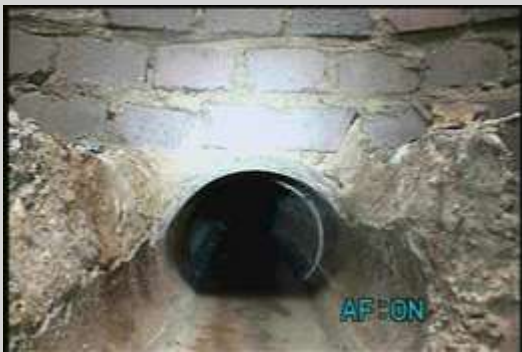
12 O'Clock Outflow

8 in. Circular Gravity Sewer
Pipe Out @ 12 O'Clock

Pipe Material: **Clay** ☐ Pipe Lined

Invert Depth: **6.40** (ft.) Flow Characteristics: **Fast**

Deposits: ☒ None ☐ Mud ☐ Sludge ☐ Debris ☐ Grease

Infiltration: **None** Pipe Seal Cond: **Unknown**

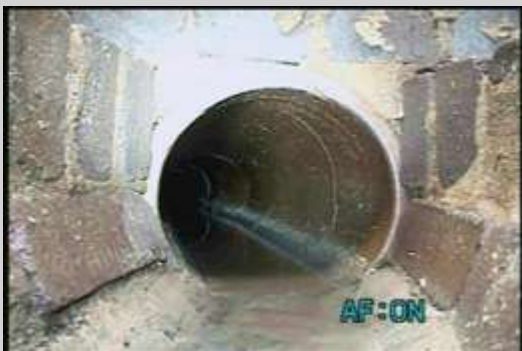
3 O'Clock Inflow

8 in. Circular Gravity Sewer
Pipe In @ 3 O'Clock

Pipe Material: **Clay** ☐ Pipe Lined

Invert Depth: **6.30** (ft.) Flow Characteristics: **Fast**

Deposits: ☒ None ☐ Mud ☐ Sludge ☐ Debris ☐ Grease

Infiltration: **None** Pipe Seal Cond: **Unknown**

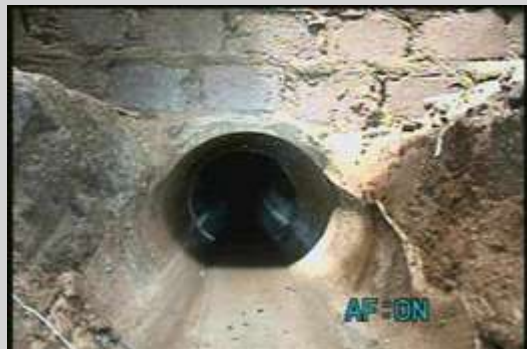
6 O'Clock Inflow

8 in. Circular Gravity Sewer
Pipe In @ 6 O'Clock

Pipe Material: **Clay** ☐ Pipe Lined

Invert Depth: **6.30** (ft.) Flow Characteristics: **Fast**

Deposits: ☒ None ☐ Mud ☐ Sludge ☐ Debris ☐ Grease

Infiltration: **None** Pipe Seal Cond: **Unknown**
